Virginia Department of Forestry BMP Effort, Implementation, and Effectiveness Field Audit

•
November 2004

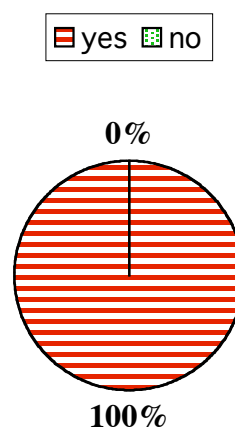
Efforts to implement BMPs were evident at 100% of inspected timber harvests, up from the 93% recorded in June 2004, (*fig.1*). Quality of effort, rated on a scale of 1(poor) to 5(excellent), averaged 2.7, down from the 3.1 average of June 2004. Implementation of all necessary BMPs to

Fig. 1: Has An Effort Been Made To Apply BMPs, Regardless Of Meeting Technical Specifications?

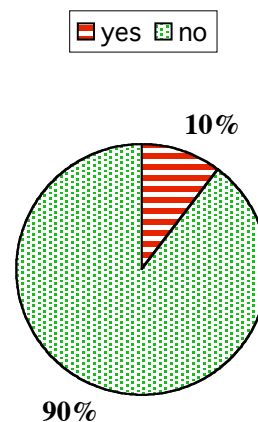
DOF standards occurred at 10% of inspected sites, down from the 17% recorded in June 2004 (*fig. 2*).

Fig. 2: Were All BMPs Applied To Technical Specifications As Expressed In The BMP Manual?

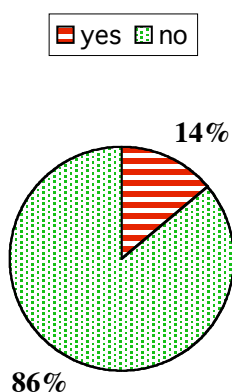
Active sedimentation existed at 14% of the inspected sites; down from the 17% recorded in June 2004, (*fig. 3*). The potential for sedimentation was noted at 14% of the inspected sites, up from the 7% noted in June 2004, (*fig. 4*).

Fig. 3: Does Active Sedimentation Exist Now Because BMP Technical Specifications Were Not Met?

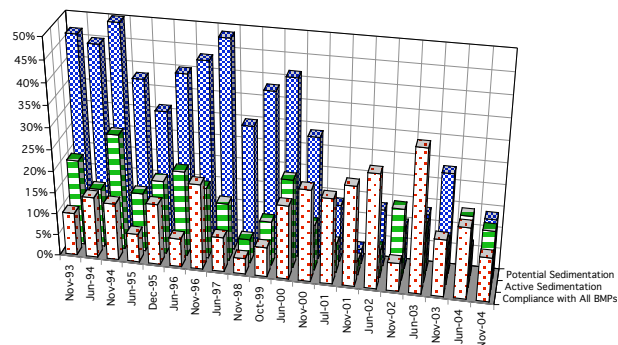
Fig. 5: Three Trends
